# UNDERWATER BRIDGE INSPECTION REPORT

STRUCTURE NO. 1461

BLUE EARTH RIVER

MINNESOTA DEPARTMENT OF TRANSPORTATION  
UNDERWATER BRIDGE INSPECTION

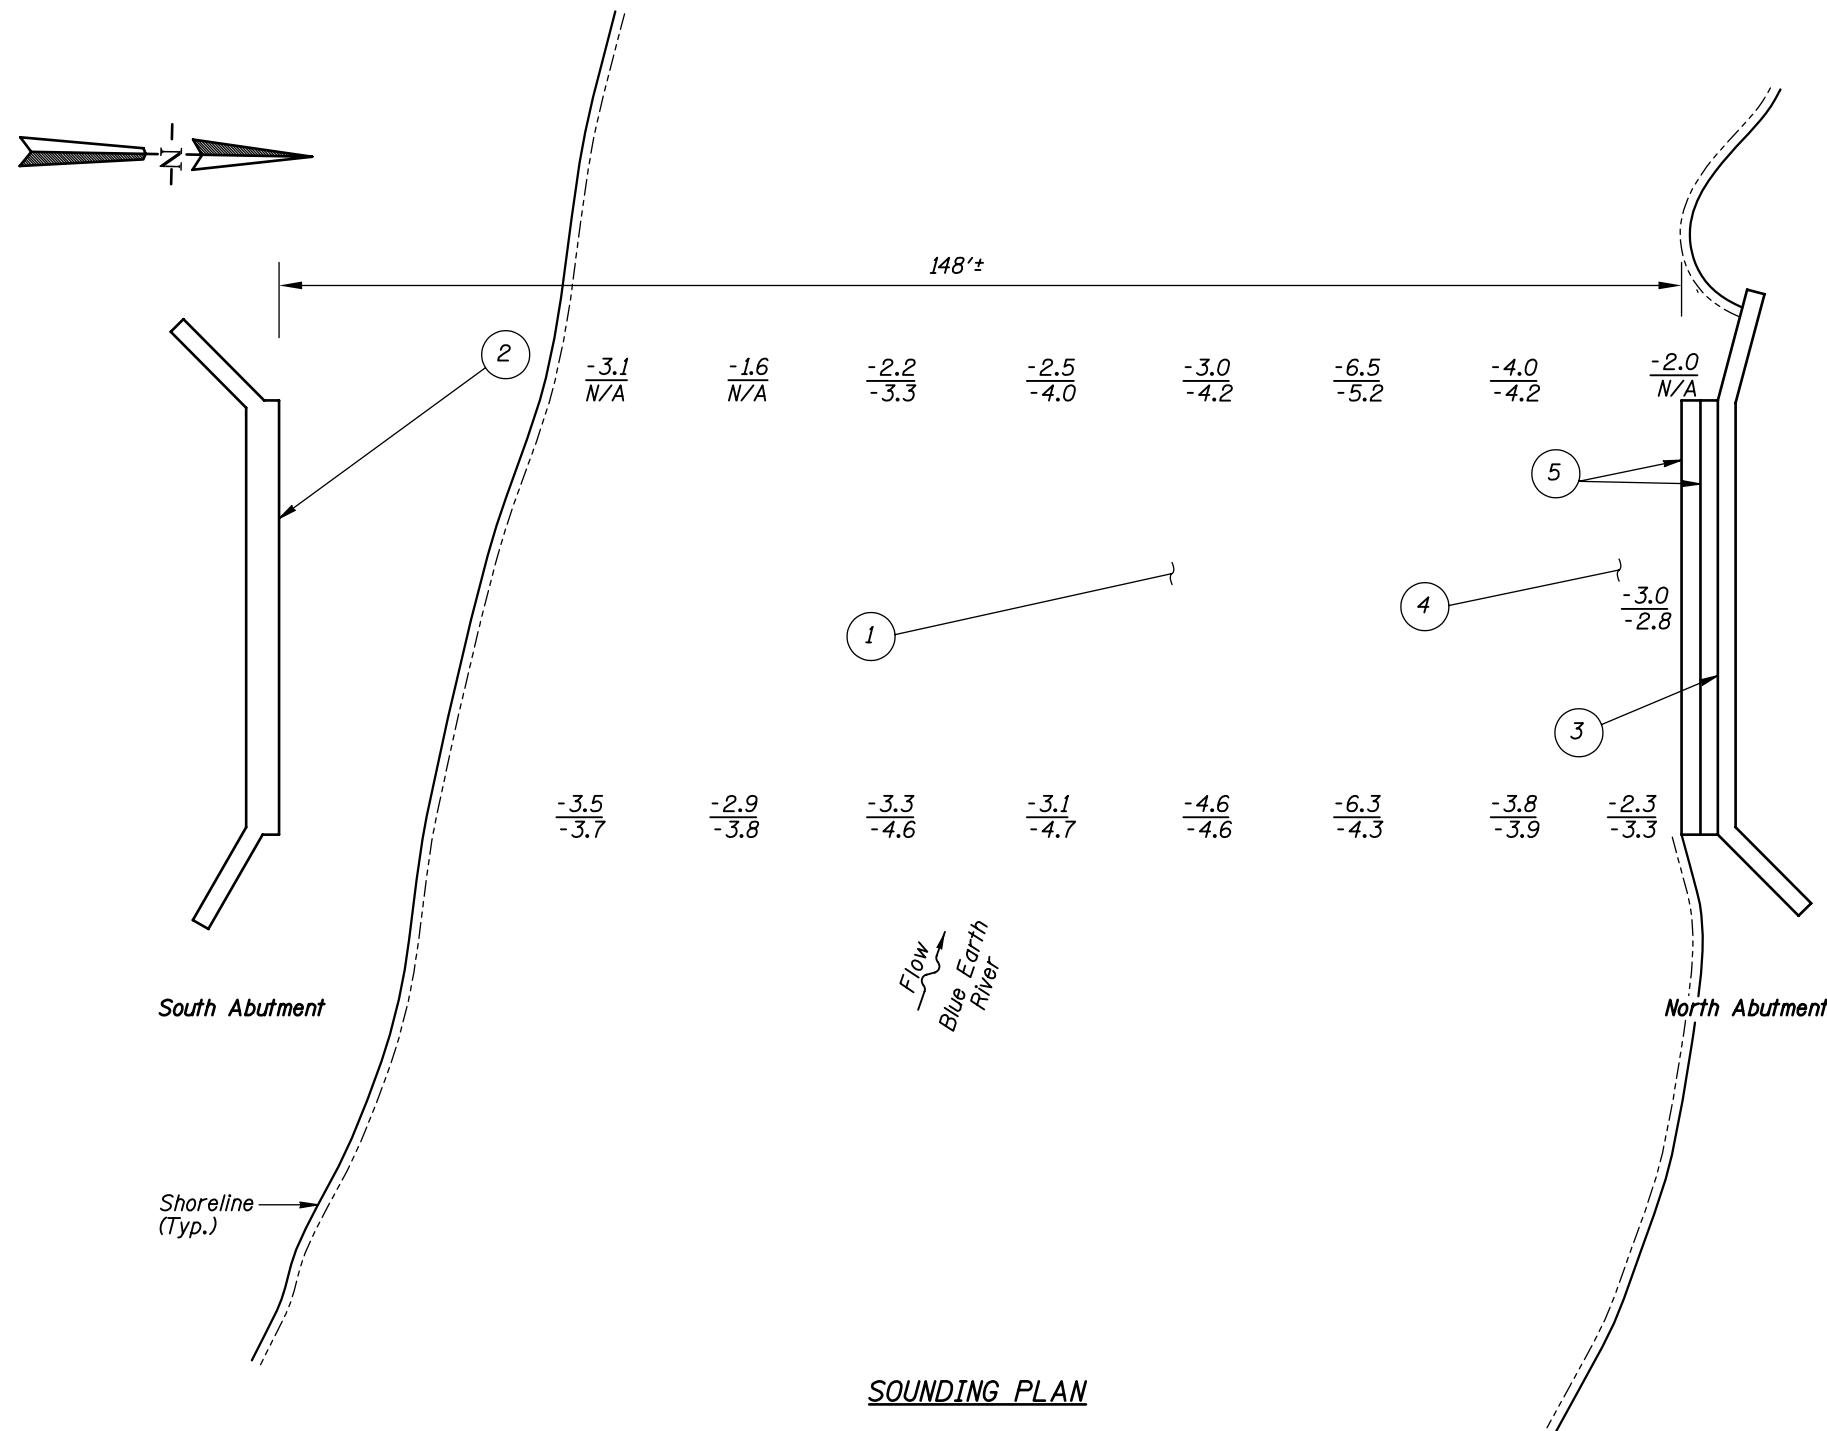
- INSPECTION NOTES:**
1. The channel bottom material consisted of firm silty sand with 3 inches of probe rod penetration.
  2. Random voids were observed in the previously repaired mortar joints on the South Abutment, up to 1/2 inch wide with 3 inches of maximum penetration. The east abutment corner and wingwall has been repaired with concrete which was in good condition.

3. The masonry of the North Abutment has been repaired with concrete from 2 feet above the top step to the mudline. The east wingwall has also been repaired with concrete. The concrete is generally sound and rough formed with some voids and random poor consolidation with up to 6 inches of maximum penetration. Random voids, cracks and loss of section were observed in several locations along the masonry blocks.

4. The channel bottom along the North Abutment consisted of concrete rubble and riprap with sandy infilling.
  5. Two concrete steps were observed in front of the breast wall of the North Abutment. The tops of the steps were located at 3.8 feet and 1.0 feet below the waterline.

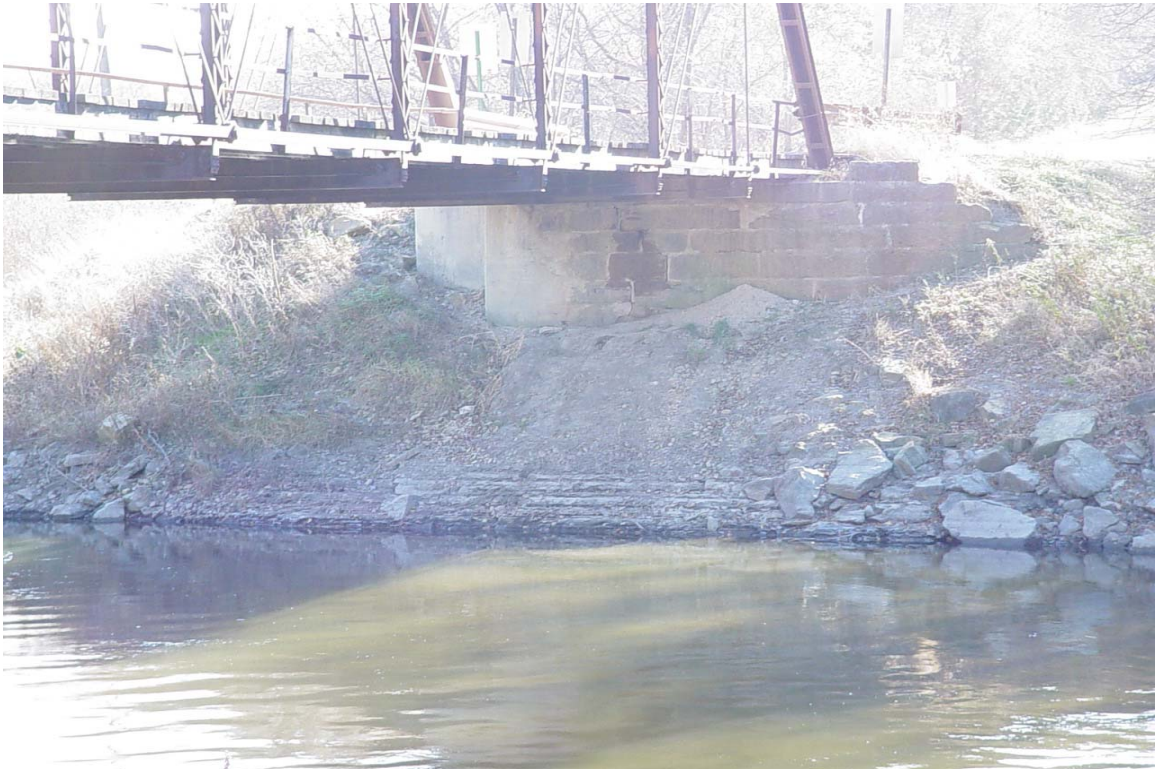
- (A) Random areas of section loss were observed in the previously repaired mortar joints on the South Abutment, with deficiencies up to 1/2 inch wide having 3 inches of maximum penetration.
- (B) The masonry of the North Abutment has been encased with concrete from 2 feet above the top step to the mudline. The east wingwall has also been repaired with concrete. The concrete repairs were generally in good condition with several voids and random areas of poor consolidation with up to 6 inches of maximum penetration. Random voids, cracks, and loss of section were also observed in several locations along the mortar joints of the masonry blocks.

Photograph 2. View of the South Abutment, Looking South.

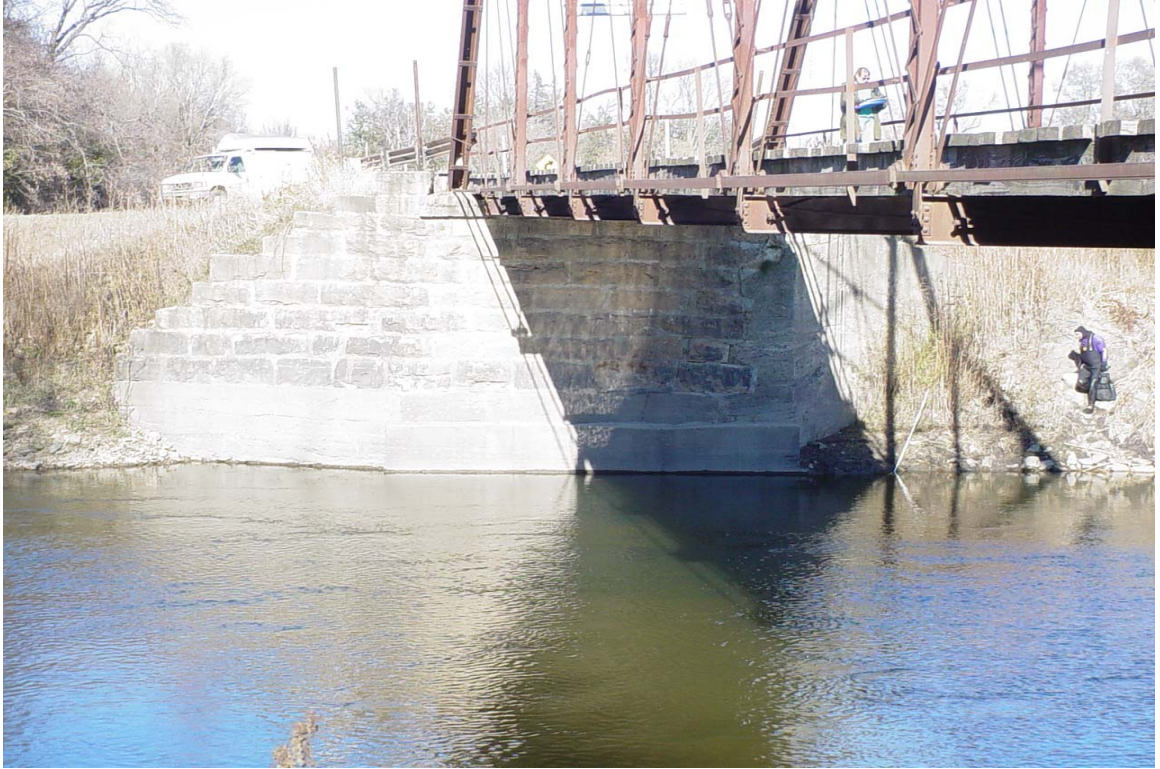
Photograph 3. View of the North Abutment, Looking Northeast.
